# Manhole Inspection Summary

Manhole # S27C1\_008MH

Insp Date: **4/15/08 11:41 AM**

**Location** Address: **2245 SIDNEY AV.**

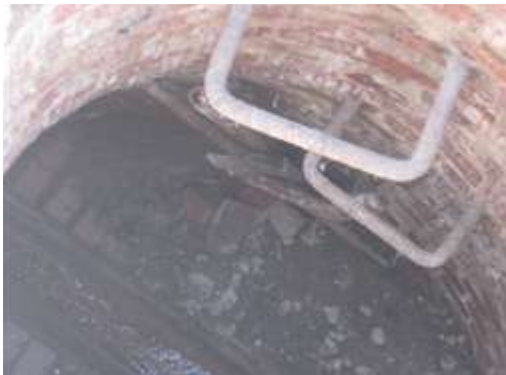
Defect 2

Condition: ☐ Sound ☐ Cracked ☐ Root Intrusion ☐ Deteriorated ☐ Leaks ☒ **Debris**

**Steps** Count: **4** Missing: **0** ☒ **Corroded**

DEBRIS ON BENCH & CORRODED RUNG

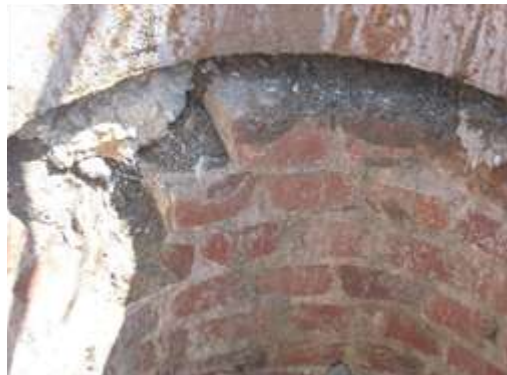
Defect 1

Condition: ☐ Sound ☒ **Cracked** ☐ Root Intrusion ☒ **Loose Brick** ☒ **Deteriorated**

Infiltration: ☐ None ☐ Joint ☐ Cracks ☒ **Mortar** ☐ Roots ☐ Wall

Loose Bricks, Cracks and Deterioration in Chimney, Chimney Infiltration

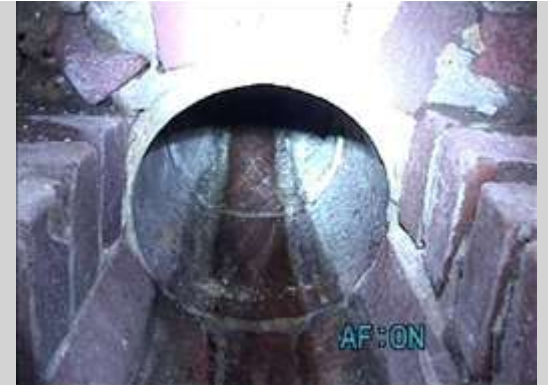
12 O'Clock Outflow

8 in. Circular Gravity Sewer  
Pipe Out @ 12 O'Clock

Infiltration: **None** Pipe Seal Cond: **Sound**

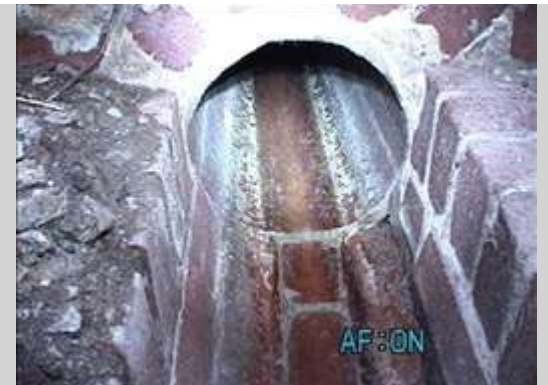
6 O'Clock Inflow

8 in. Circular Gravity Sewer  
Pipe In @ 6 O'Clock

Infiltration: **None** Pipe Seal Cond: **Sound**
